Section A. Facility Data
Facility No. 375
Facility Descriptor: Guard Post
Project: RISS
Date of Demolition: 11/08/2003
Additional Information: (Must include information on environmental releases and conditions of site at turnover to Environmental Restoration)

Additional Facility Information

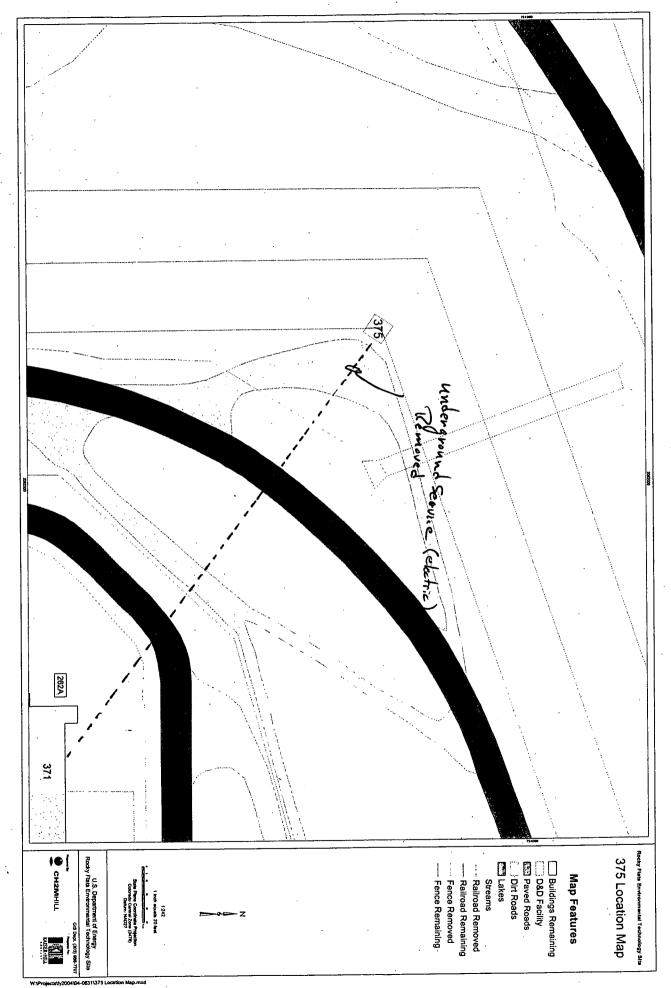
The entire facility was removed during D&D activities, and sent offsite for disposal at the BFI Foothills Landfill in Golden, CO. The electrical connection was removed, and the disconnect location is indicated on the attached map. The empty electrical conduit line remains at a depth of at least 3 feet below grade from the disconnect point to B371 as indicated on the attached map. B375 was not associated with an IHSS, PAC or UBS, and no further work remains other than to establish the final site grade.
